CASE REPORT

Horror of three synergistic factors in THA: high mechanical stress, dissimilar metals, low elasticity stem: a case report

Case presentation: A 70-year-old woman underwent revision surgery 7.5 years after total hip arthroplasty because of catastrophic stem corrosion with dissociation of the metal head (cobalt/chromium) and stem (TiMo12Zr6Fe2). Abnormal levels of cobalt were found in the intra-articular fluid, capsule, hip muscle, and blood. Revision surgery was performed via the direct anterior approach. The well-fixed femoral stem was explanted, and a cemented stainless stem with stainless head was implanted. Three months after the revision surgery, the cobalt concentration in the blood had decreased to normal.

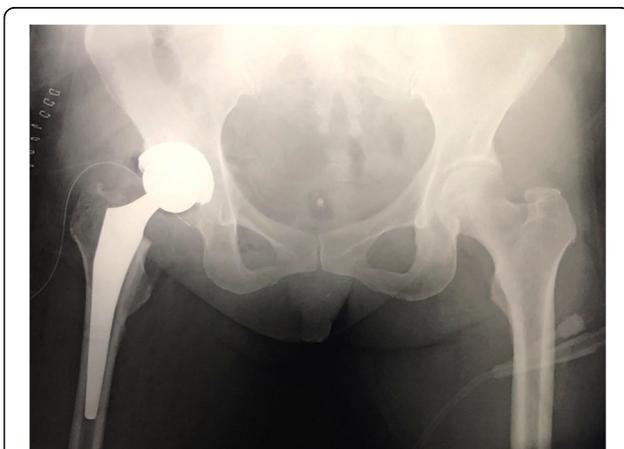
Fig. 1 Anteroposterior plain radiography of both hips after total hip arthroplasty (THA)

Laboratory data showed a normal C-reactive protein level (0.12 mg/dl) but abnormal serum levels of cobalt (7.0 µg/L, normal <1 µg /L) and chromium (3.7 µg/L, normal <5 µg /L) [7]. Radiography performed just after the previous THA and prior to this admission showed no abnormalities in cup inclination (33°) or anteversion angle (19°) (Fig. 1). However, each offset in the right hip was longer than that in the left hip (femoral/acetabular/total offset: 43.7/38.6/82.3 (right) and 42.1/33.1/75.2 (left)). Leg length was 2 mm longer on the operative side than on the healthy side [8]. Plain radiography at the time of the present admission showed implant dissociation between the stem and head, with stem tip malformation (Fig. 2). Plain computed tomography and magnetic resonance imaging showed a mass (72 × 22 × 32 mm) that was partially calcified around the hip joint. We therefore suspected femoral head-stem trunion dissociation secondary to corrosion after THA with a large-diameter metal head that required revision surgery.

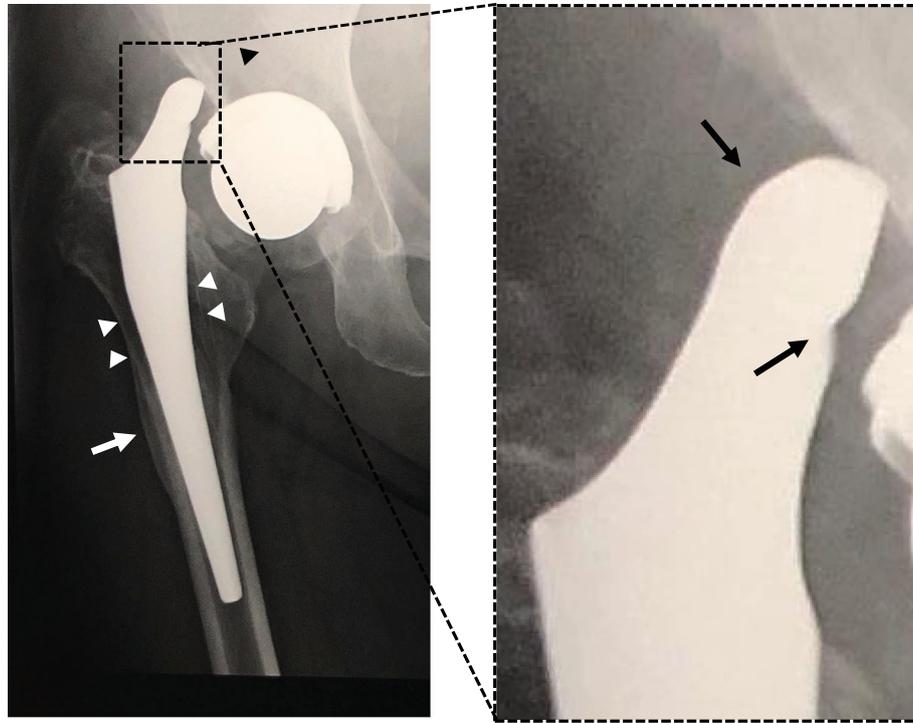
Fig. 2 Radiography obtained 7.5 years after total hip arthroplasty (THA). There is dissociation of the femoral head from the head-stem trunnion (right panel, box) after THA (right panel, black arrows), radiolucency (left panel: black arrowhead, and white arrowheads), and cortical hypertrophy (white arrow)

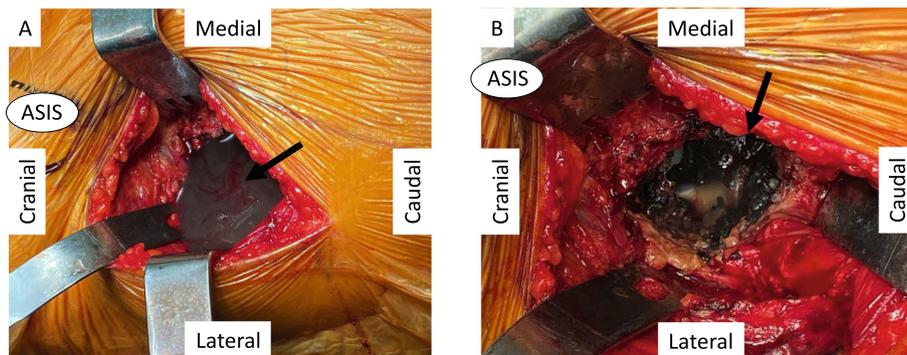
Surgery was performed using a direct anterior approach on a traction table [9]. Before opening the capsule, the rectus femoris and tensor fascia lata were biopsied for metal ion testing. Surgical findings included a joint capsule filled with black fluid and black granulation tissue (Fig. 3A, B), as well as thickened fibrous tissue. The anterior capsule was sent for pathological examination. Tissues debrided around the capsule were severely

Fig. 3 Intraoperative photographs. **A** Pigmented metal around the joint (arrow). **B** Black granulation tissue adhering to the inner surface of the joint capsule (arrow)

affected by metal ions. The pigmented granulation tissue in the joint was removed.

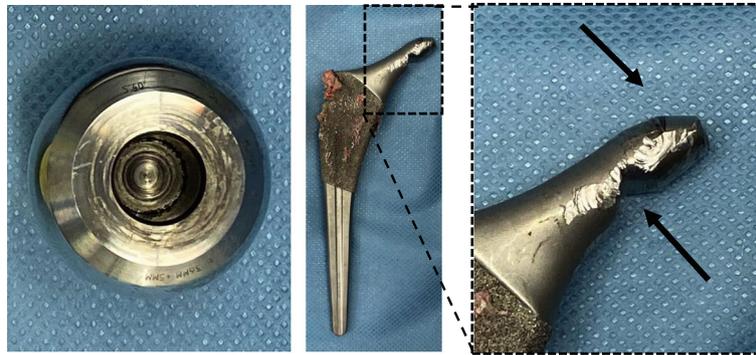
There was no loosening of the cup or stem. The removed head-stem junction was severely deformed and worn (Fig. 4). The acetabular cup was well fixed. The polyethylene liner was replaced with a metal liner for the dual mobility cup. The well-fixed femoral stem was explanted without fracture, and a cemented stem was implanted [Exeter V40 (offset 37.5 mm, # 2); Stryker] (Fig. 5). Total right hip femoral offset was intentionally decreased from 82.3 to 63.8 mm (lower than that of the left hip). Leg-length discrepancy was corrected to within 1 mm.

Fig. 4 Photographs of the extracted instrumentation. Left panel: metal debris inside the metal head. Middle and right panels: significant deformation at the head-stem trunnion (arrows)

Although previous reports suggested other risk factors—*e.g.*, body weight, high neck offset, and activity level [10–18]—we believe that the three major potentially linked factors that contributed to the onset of trunionosis in our patient were increased mechanical stress at the trunion, contact of dissimilar metals at the trunion, and use of an Accolade TMZF stem.

Second, contact between dissimilar metals can cause galvanic corrosion due to an electrochemical process resulting from electron flow [15, 20]. Although titanium stems and cobalt/chromium heads have individual advantages, the combination of these metals could

Third, the nature of the Accolade TMZF negatively affects the onset of trunnionosis. Stems made of TMZF alloy have a low Young's modulus of elasticity. The Young's modulus is proportional to the flexural rigidity and that of Ti-6Al-4V is 119 GPa while that of TMZF is 82 GPa [16]. The low flexural rigidity of TMZF is a risk factor for taper corrosion [17]. Krishnan *et al* reviewed modular femoral stems and found the most failures with a TMZF stem and cobalt/chromium stem combination [18]. Thus, combined ABG2 and Rejuvenate modular stems (Stryker, Kalamazoo, MI, USA) were recalled because of high revision rates due to corrosion. In addition, a systematic review reported that the Accolade TMZF poses a serious risk of trunnionosis, with trunnionosis occurring in 34/46 cases using the Accolade TMZF [11]. Although low flexural rigidity may have the advantage of normal load transmission to native bone, appropriate strength with high safety should be guaranteed.

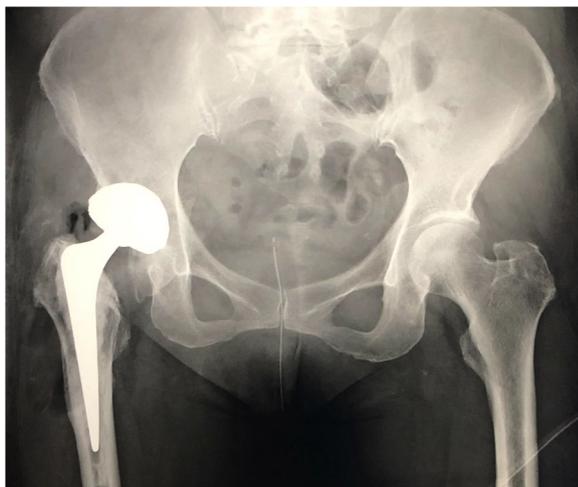
Fig. 5 Postoperative radiography showing the cemented femoral stem

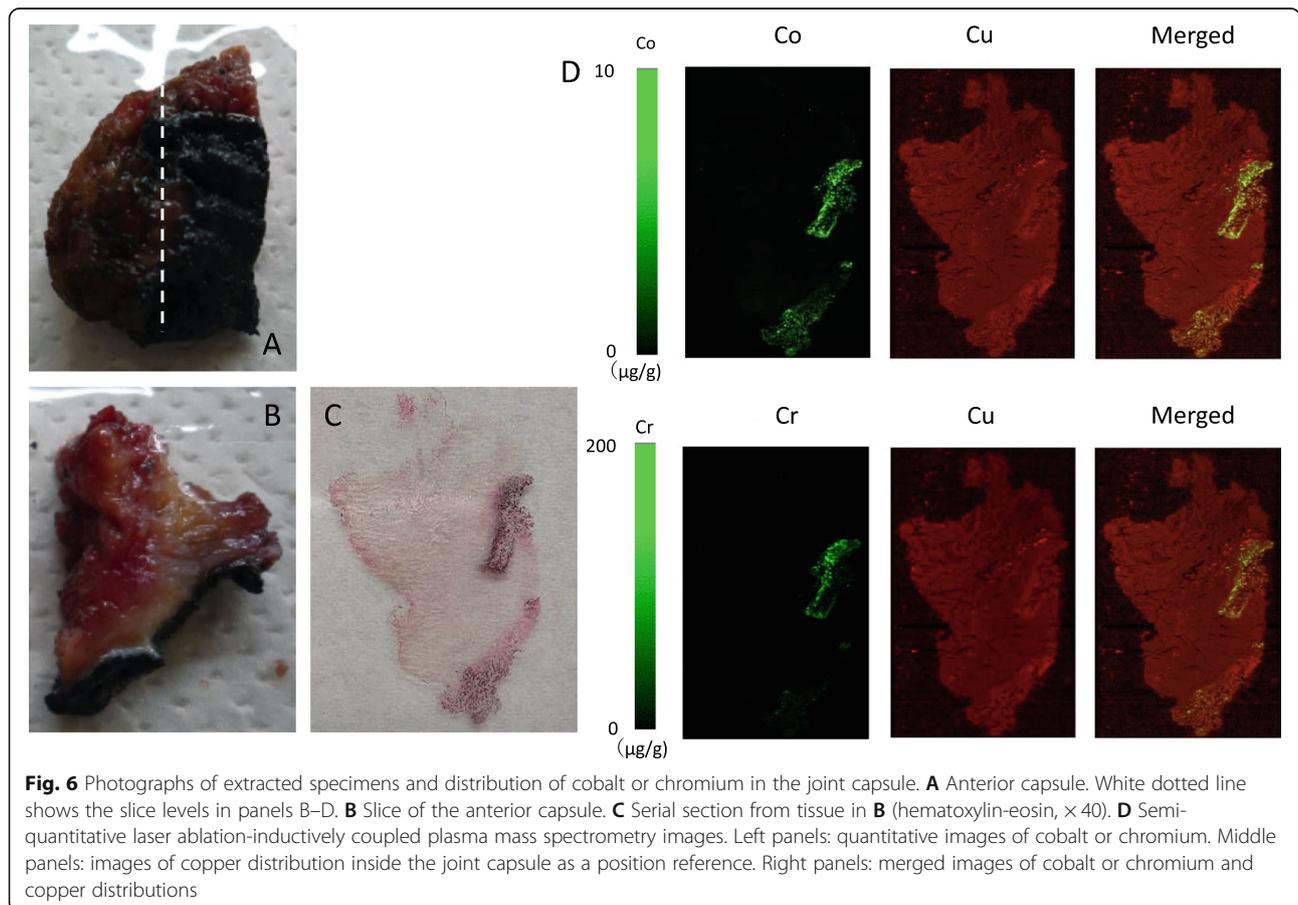
The microbial cultures of the joint fluid were negative. Pathological examination revealed necrotic tissue with fibrosis. Cobalt/chromium metal levels were elevated in synovial fluid, joint capsule, rectus femoris, and fascia lata (Table 1). Frozen tissue sections (5-µm thick) of the anterior joint capsule were processed. The distribution of cobalt or chromium in the joint capsule—determined by laser ablation (NWR213; Elemental Scientific Lasers, Tokyo, Japan) and inductively coupled mass spectrometry (LA-ICP-MS) (Agilent 8800; Agilent Scientific, Santa Clara, CA, USA)—is shown in Fig. 6. Concentrations were estimated using the results of conventional LA-ICP-MS after acid digestion of the neighboring tissue. Both cobalt and chromium were distributed on the inner surface of the joint capsule as small particles. Semiquantitative LA-ICP-MS images showed cobalt/chromium on the inner surface of the joint capsule (Fig. 6D).

Fig. 6 Photographs of extracted specimens and distribution of cobalt or chromium in the joint capsule. **A** Anterior capsule. White dotted line shows the slice levels in panels B–D. **B** Slice of the anterior capsule. **C** Serial section from tissue in **B** (hematoxylin-eosin, × 40). **D** Semi-quantitative laser ablation-inductively coupled plasma mass spectrometry images. Left panels: quantitative images of cobalt or chromium. Middle panels: images of copper distribution inside the joint capsule as a position reference. Right panels: merged images of cobalt or chromium and copper distributions

Judging from the anterior capsule images of the metal concentration in the black intra-articular fluid and anterior capsule, the metal first accumulates at the joint, with the capsule a possible barrier to expansion around the hip joint. Although the cobalt blood level decreased to the normal

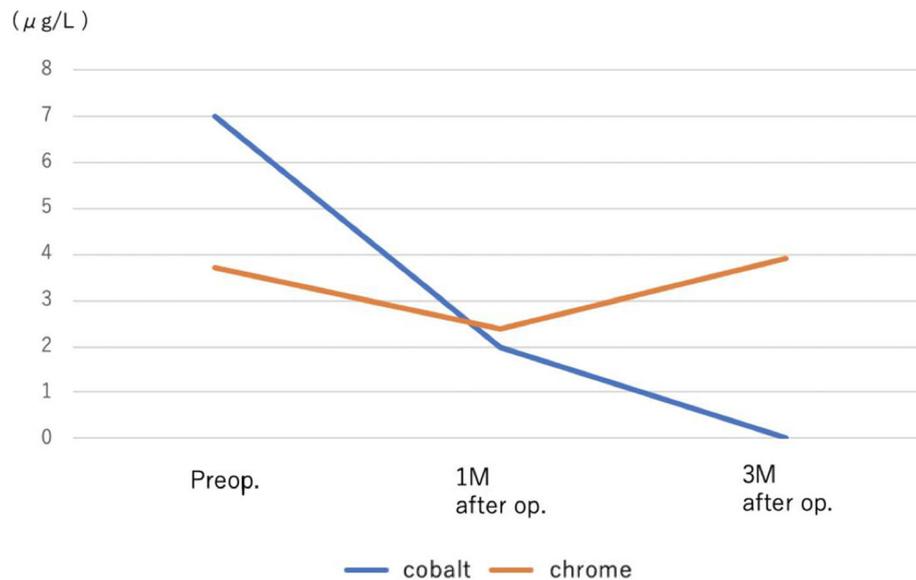
Immediate alleviation of the patient's pain was observed postoperatively, and painless walking was possible 1 month later. Her blood cobalt concentrations decreased with time and were undetectable at 3 months postoperatively (Fig. 7).

Fig. 7 Changes in postoperative blood metal (cobalt and chromium) concentrations. M, month(s); Preop., preoperatively; op., operation
